NATIONAL TRANSPORTATION SAFETY BOARD

MATERIALS LABORATORY FACTUAL REPORT

Report No. 21-081

Place : Pine Grove, Oregon
Date : August 23, 2020
Vehicle : Kaman K-1200, N314
NTSB No. : WPR20LA283
Investigator : Fabian Salazar, ASI-WPR

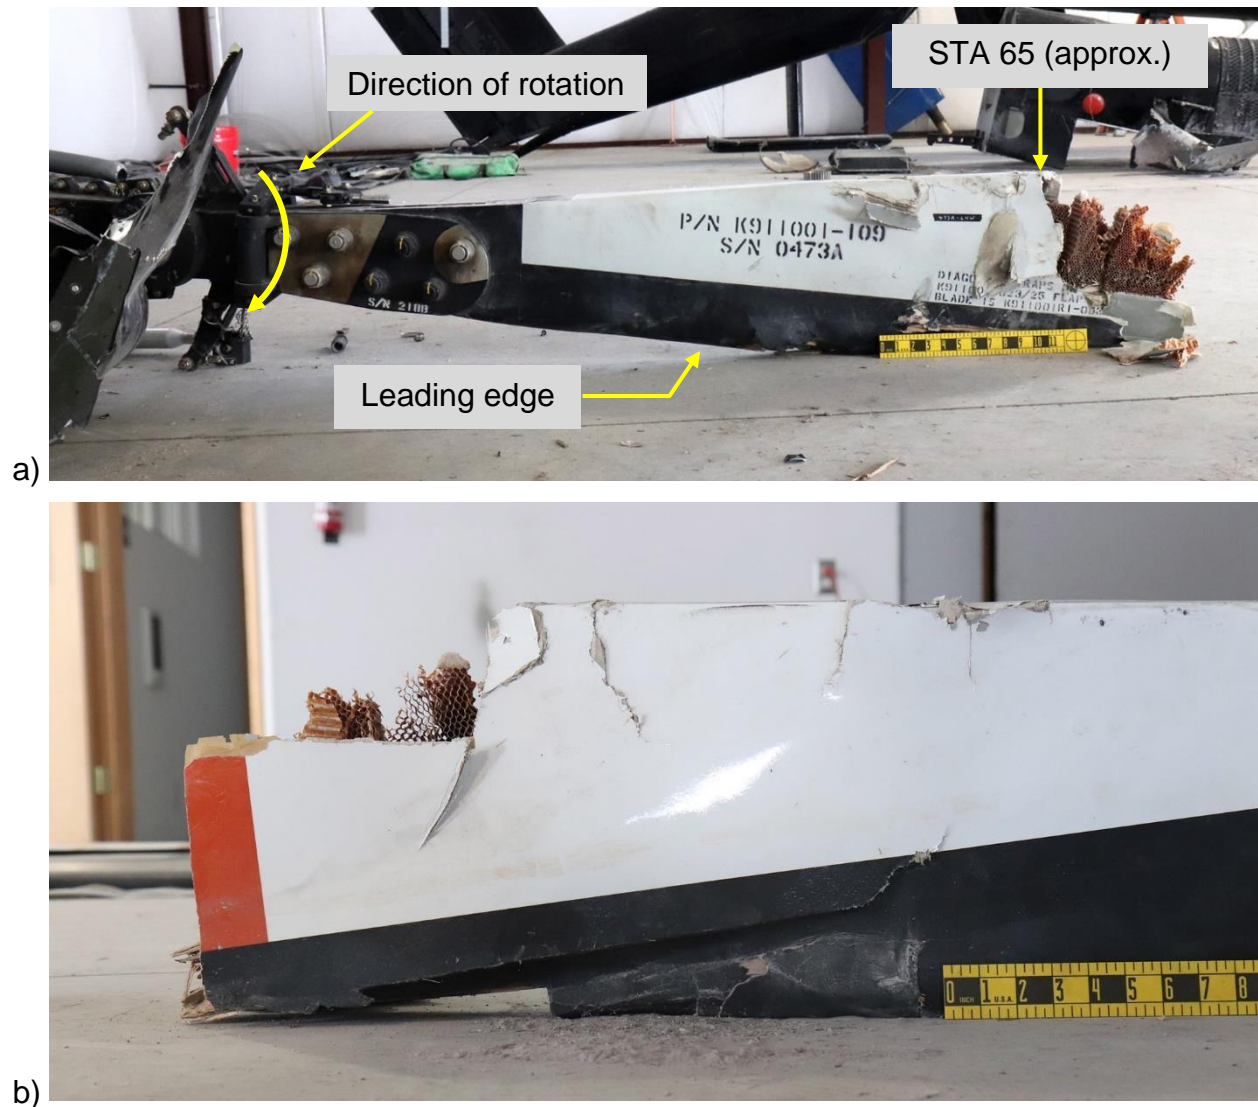
The inboard and outboard sides of the LHW main rotor blade root fracture are shown in figures 2 and 3, respectively. There were chordwise separations in the afterbody skin at approximately STA 65 and 75 and chordwise separations in the honeycomb core from trailing edge to leading edge between these stations as well. The spar was fractured in the same region. The aft portion of the spar fracture (see figures 3a and b) exhibited an oblique fracture morphology, alternating between inboard and outboard progression as the fracture transitioned between adjoining spar planks, extending outboard as far as STA 77.7. Approximately halfway across the spar, the fracture transitioned to progression

in the inboard longitudinal direction to approximately STA 67 after which it progressed in the chordwise direction along a comparatively flat path until intersecting the leading edge. The afterbody skin separation maintained its chordwise separation path across the jagged portion of the spar fracture and then followed the spar fracture along the longitudinal split and through the intersection with the leading edge. The features were consistent with a forward bending fracture.

Figure 2. Root end of the left hand white (LHW) main rotor blade (473A): a) view of the lower blade surface; b) view of the upper blade surface;

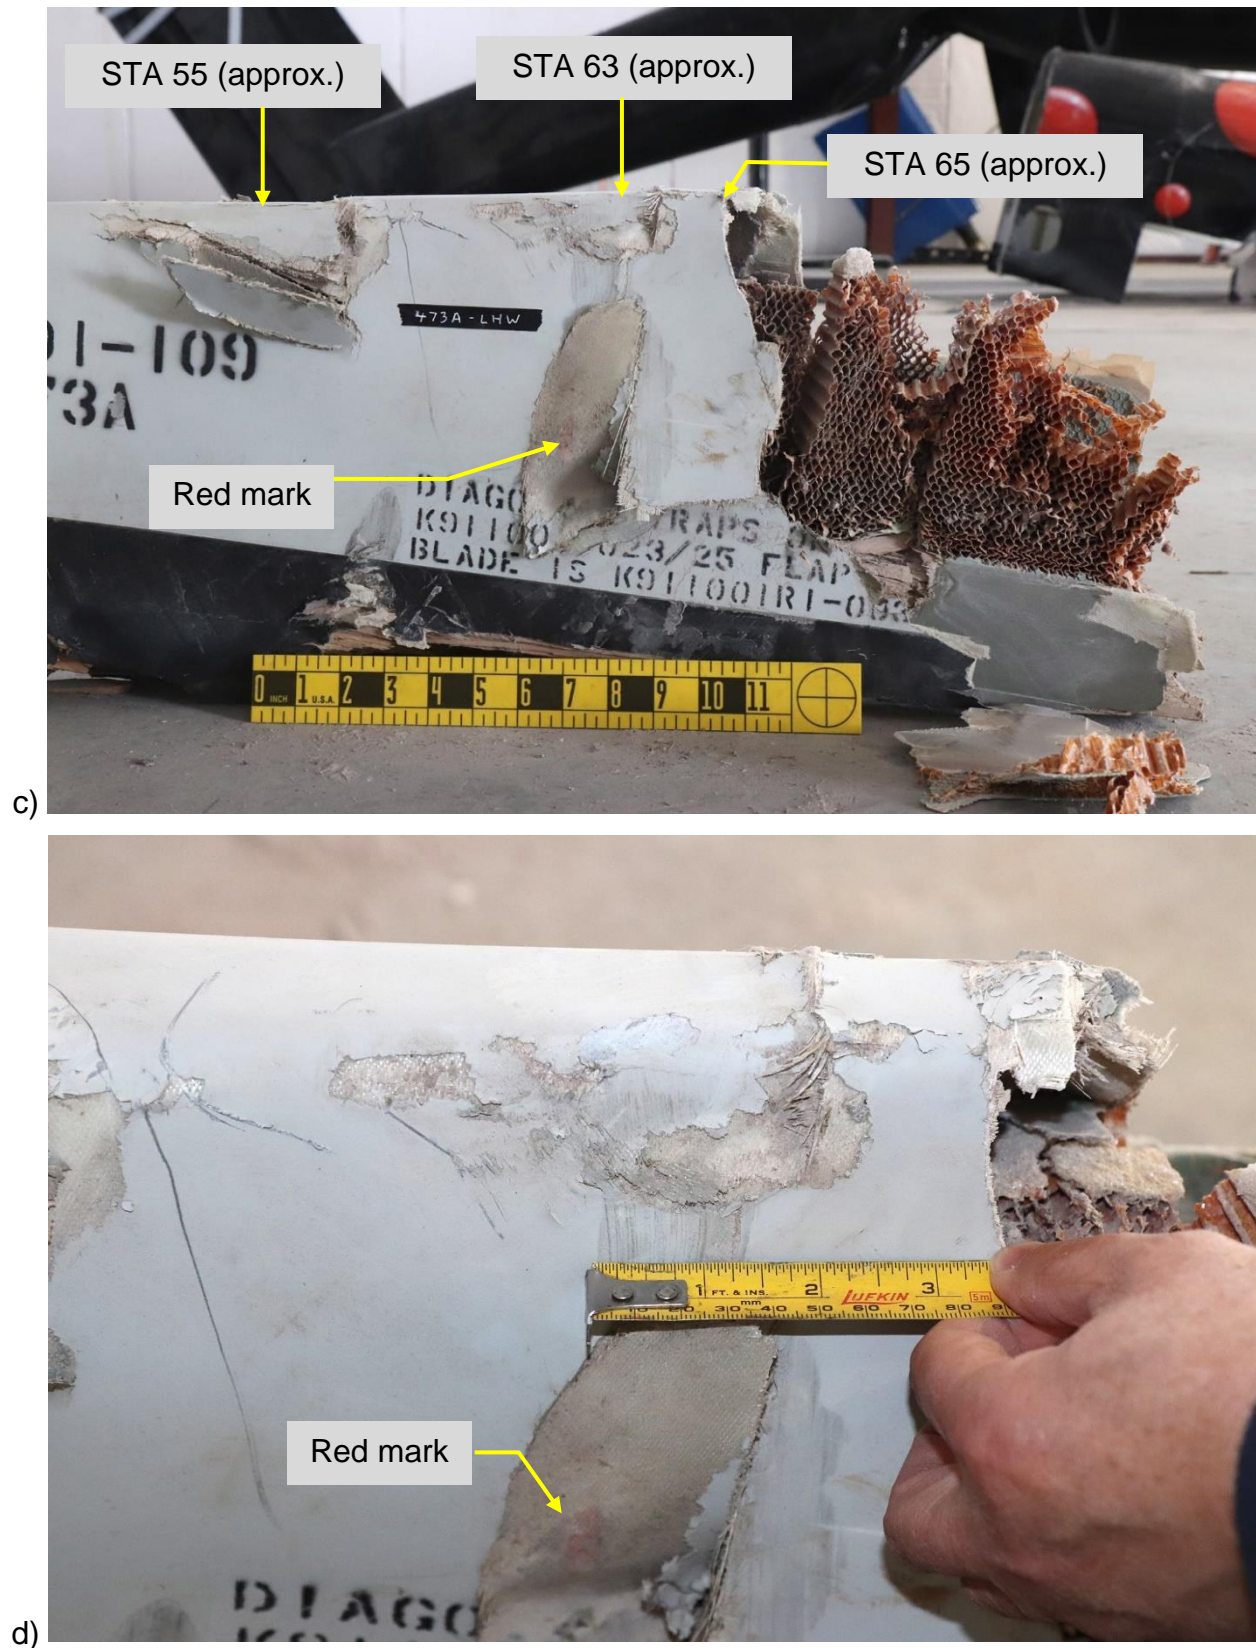
Impact marks were observed on the lower surface of the LHW rotor blade as indicated in figure 2c. One mark, at approximately STA 63 was oriented in the chordwise direction, was approximately 2 inch wide, and exhibited a red stripe mark within the contact region, as shown in greater detail in figure 2d. Examination of the right rotor hub (figures 4a and 4b) indicated that the blade hinge pivots were painted with a white or red stripe and that the upper portion of the red paint stripe on the RHR hinge pivot had been rubbed off. Another mark at approximately STA 55 had fractured the lower skin and created an indent on the lower surface.

Figure 2 (cont.). c) image near the separation showing rub and impact marks; and d) higher magnification image of the chordwise rub mark at STA 63 with a red mark indicated.

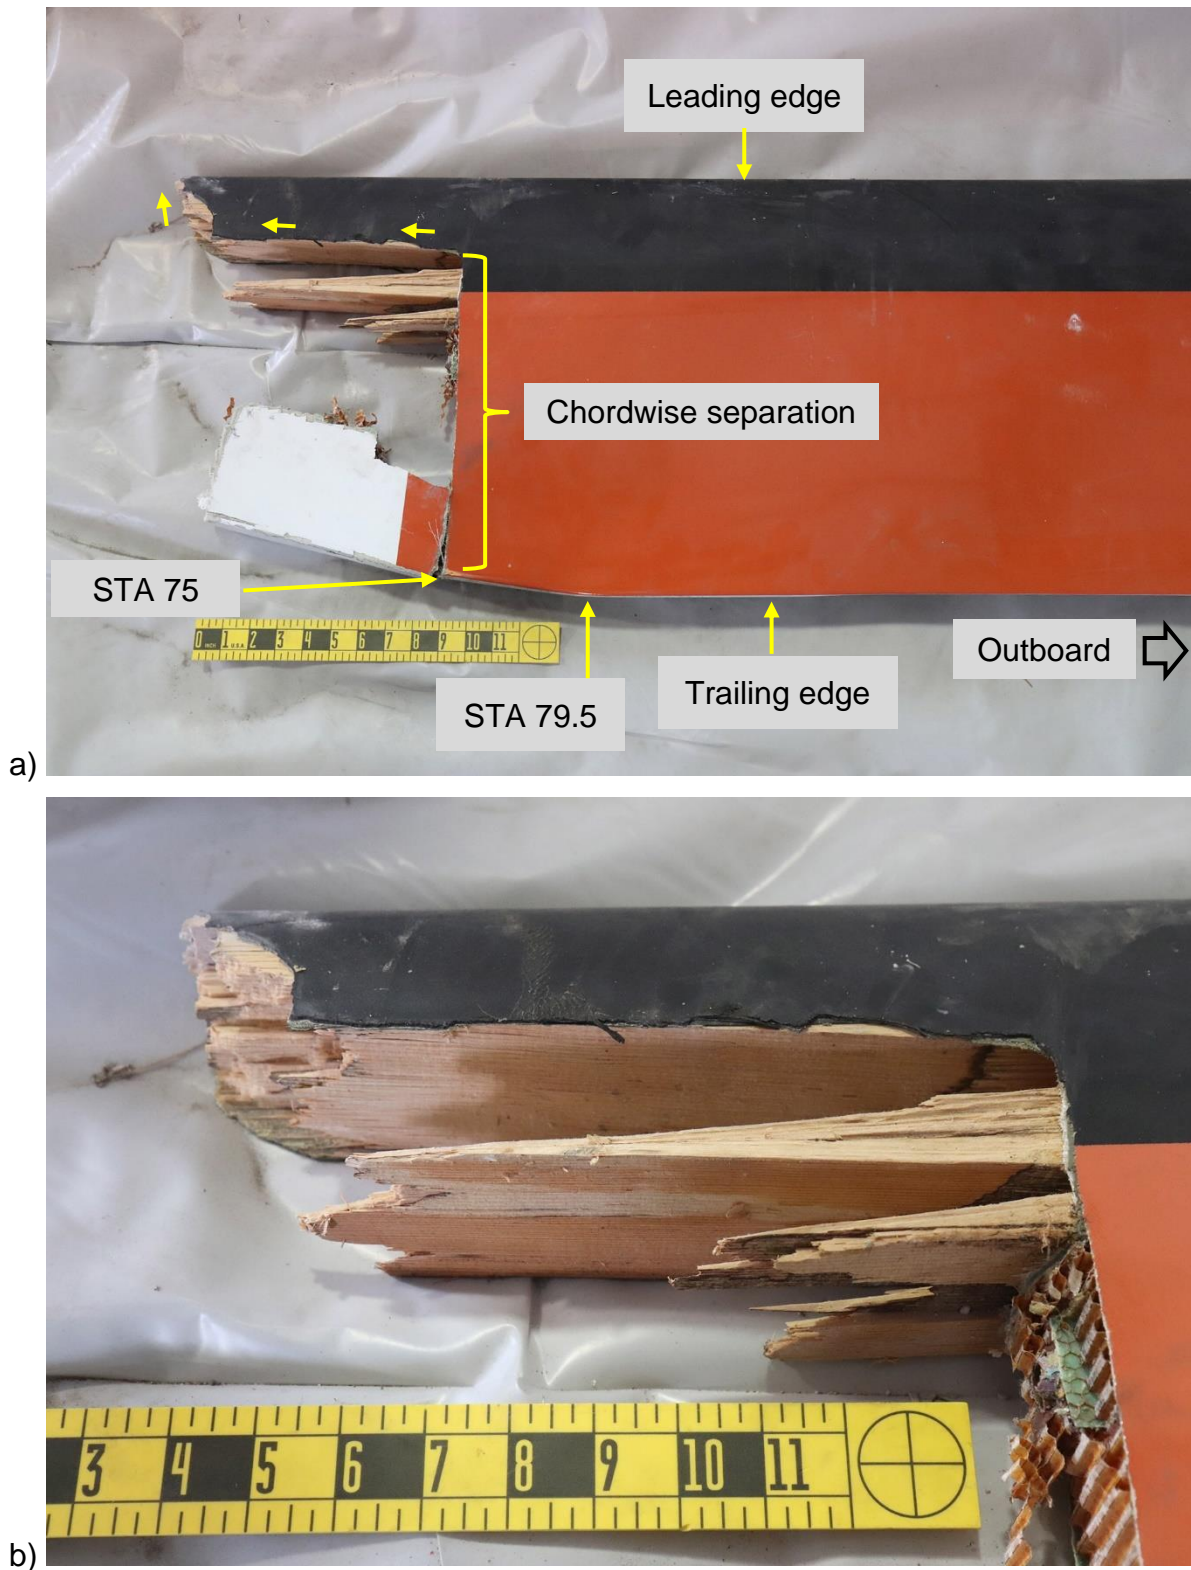
Figure 3. Outboard side of LHW (473A) main rotor blade root fracture: a) Overview image of the upper side and b) closer view of the spar fracture.

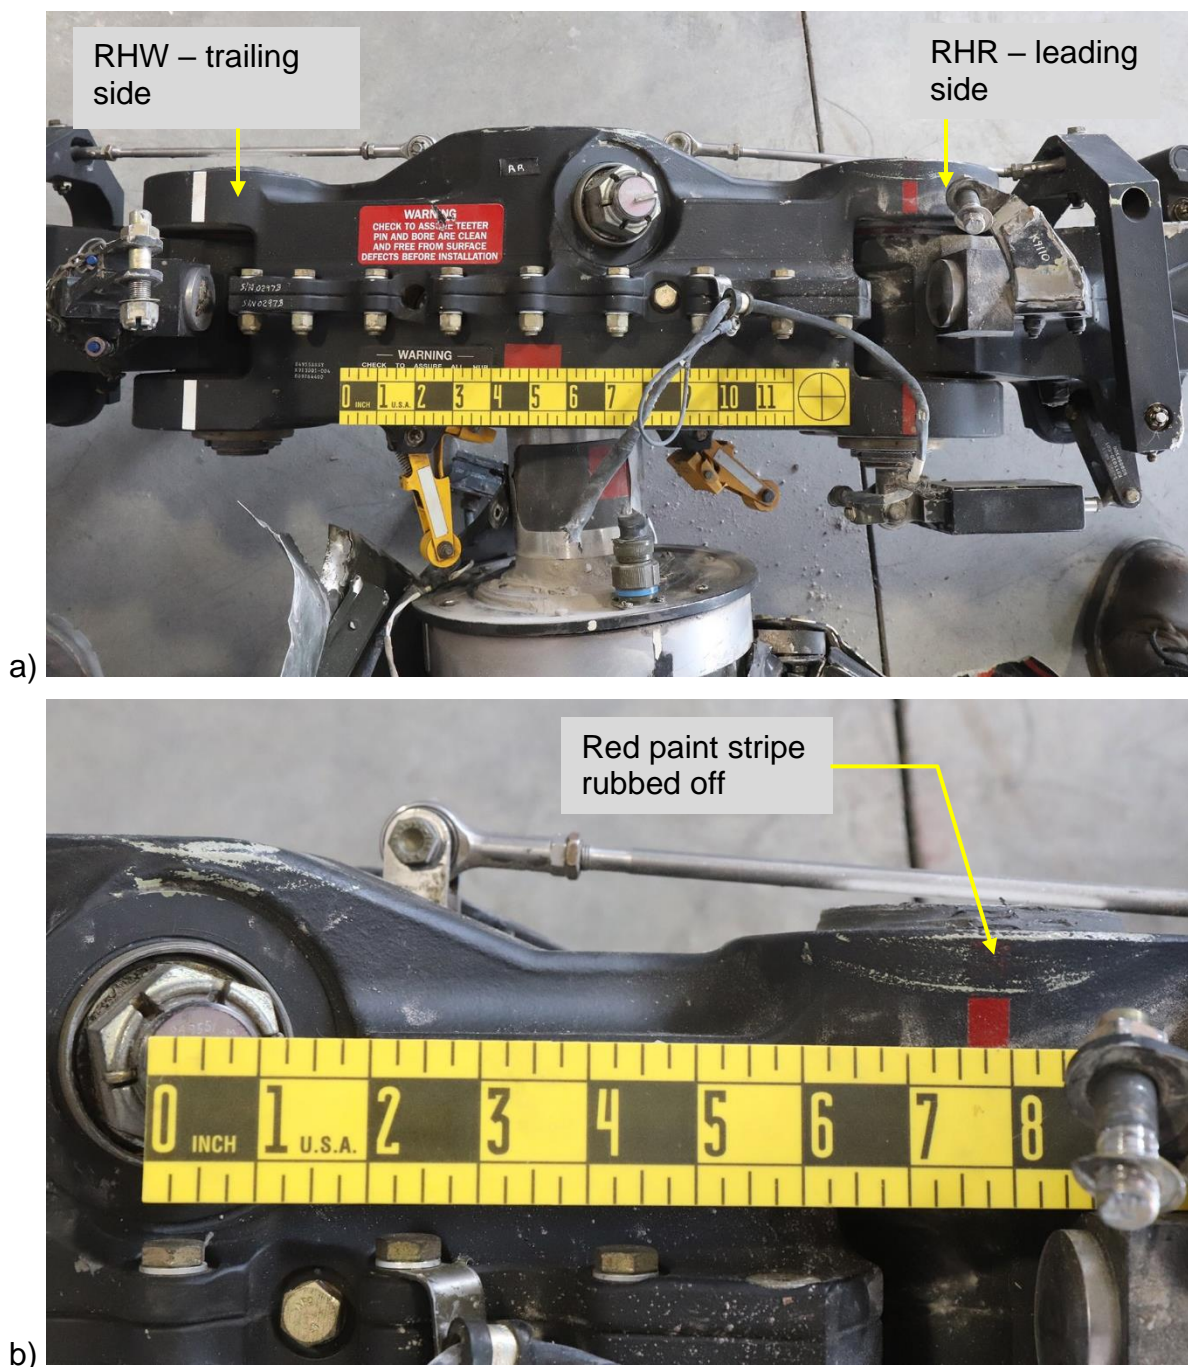
Figure 4. a) Image of the right rotor hub. The white blade (left side) rotates into the page and the red blade (right side) rotates out of the page; b) image indicating where the red paint stripe had been rubbed off the hub's red blade hinge pivot.

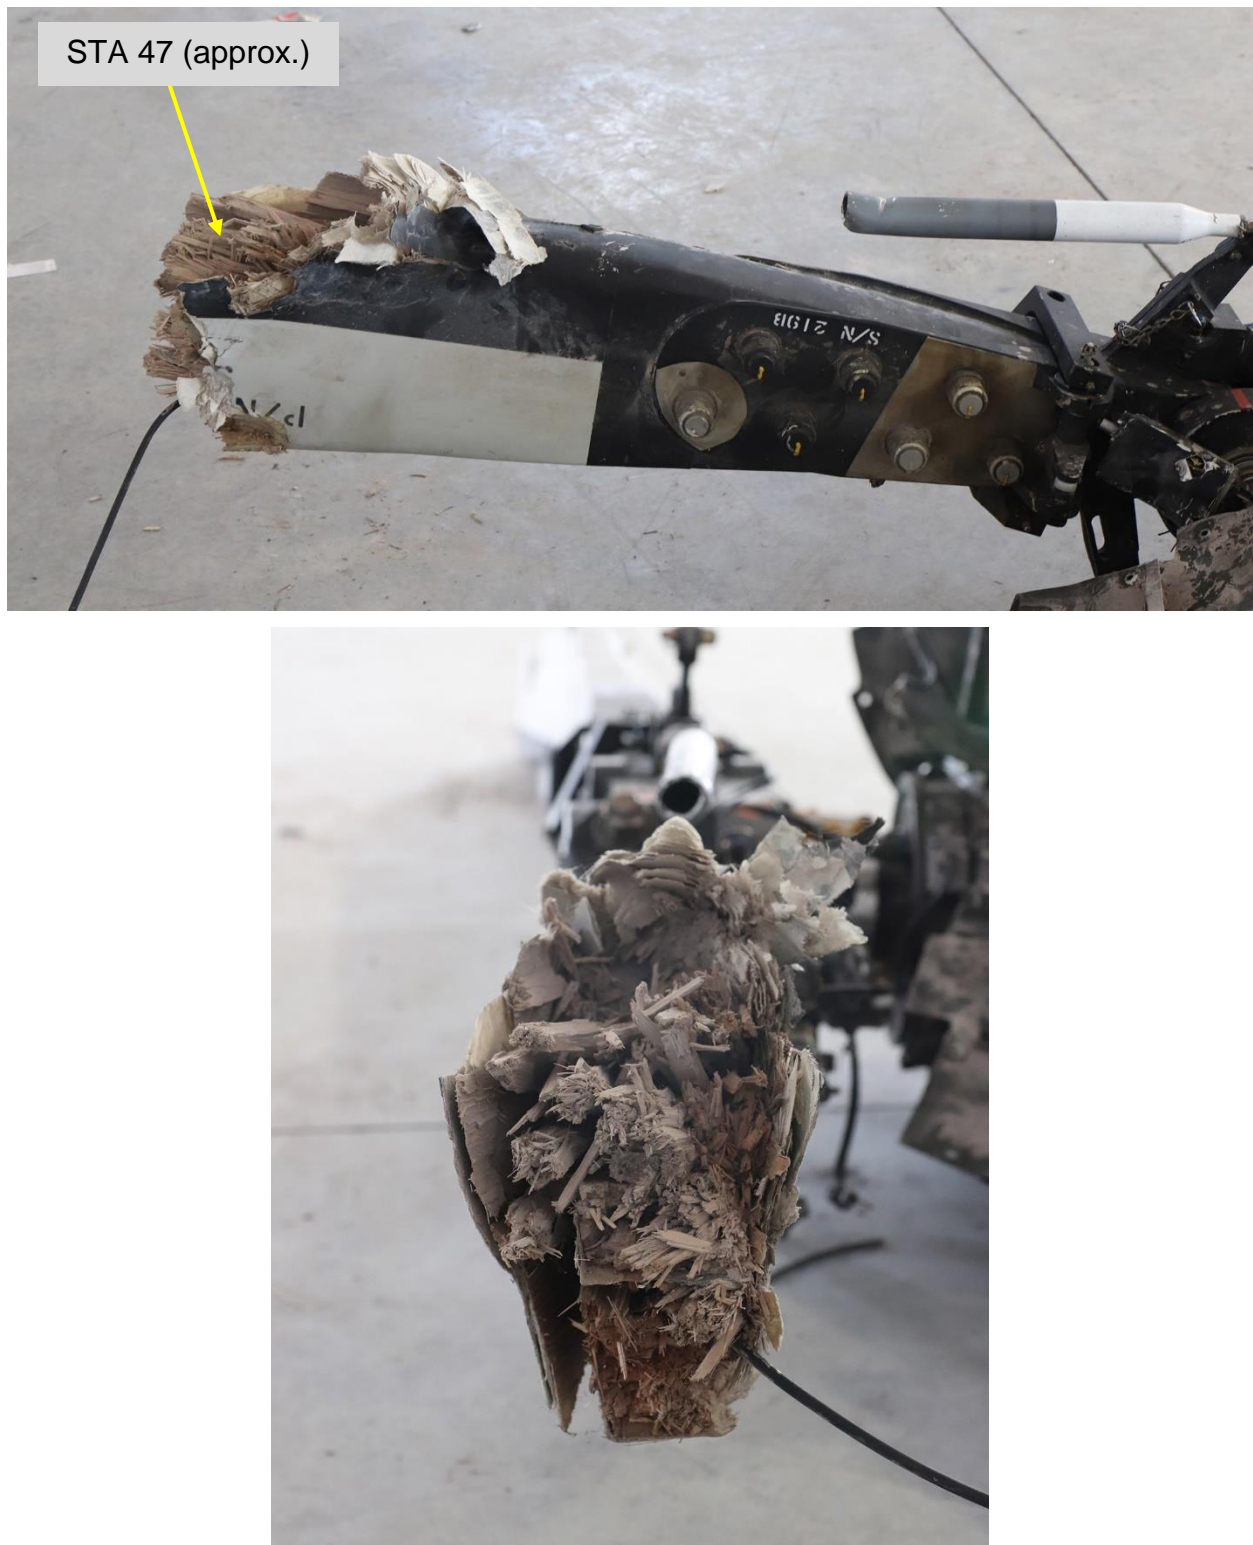
The inboard and outboard sides of the LHR main rotor blade root fracture are shown in figures 5 and 6, respectively. The inboard fracture was located between STA 47 and 48 (approx.). The wooden spar, as seen in figure 5b, appeared to be mechanically damaged, with multiple longitudinal splits, fragmented ends, and bent ends. The upper and lower blade surfaces on the outboard side of the root fracture are shown in figures 6a and 6b respectively and an oblique view of the spar fracture is shown in figure 7. On the outboard side, the spar fracture was located at approximately STA 57, leaving an approximately 9-inch to 10-inch length of the spar unaccounted for. Between STA 47 and 57, there was peel separation of the upper skin and lower skin. The outboard side of the spar fracture exhibited longitudinal splitting and fibrous features toward the aft and lower portion of the spar and exhibited flatter chopped fracture features closer to the leading edge and upper surface of the spar. The features were consistent with an upward bending fracture with possible additional forward bending.

Figure 5. Images of the LHR (473B) main rotor blade root: a) view of the lower blade surface and b) view of the fractured spar.

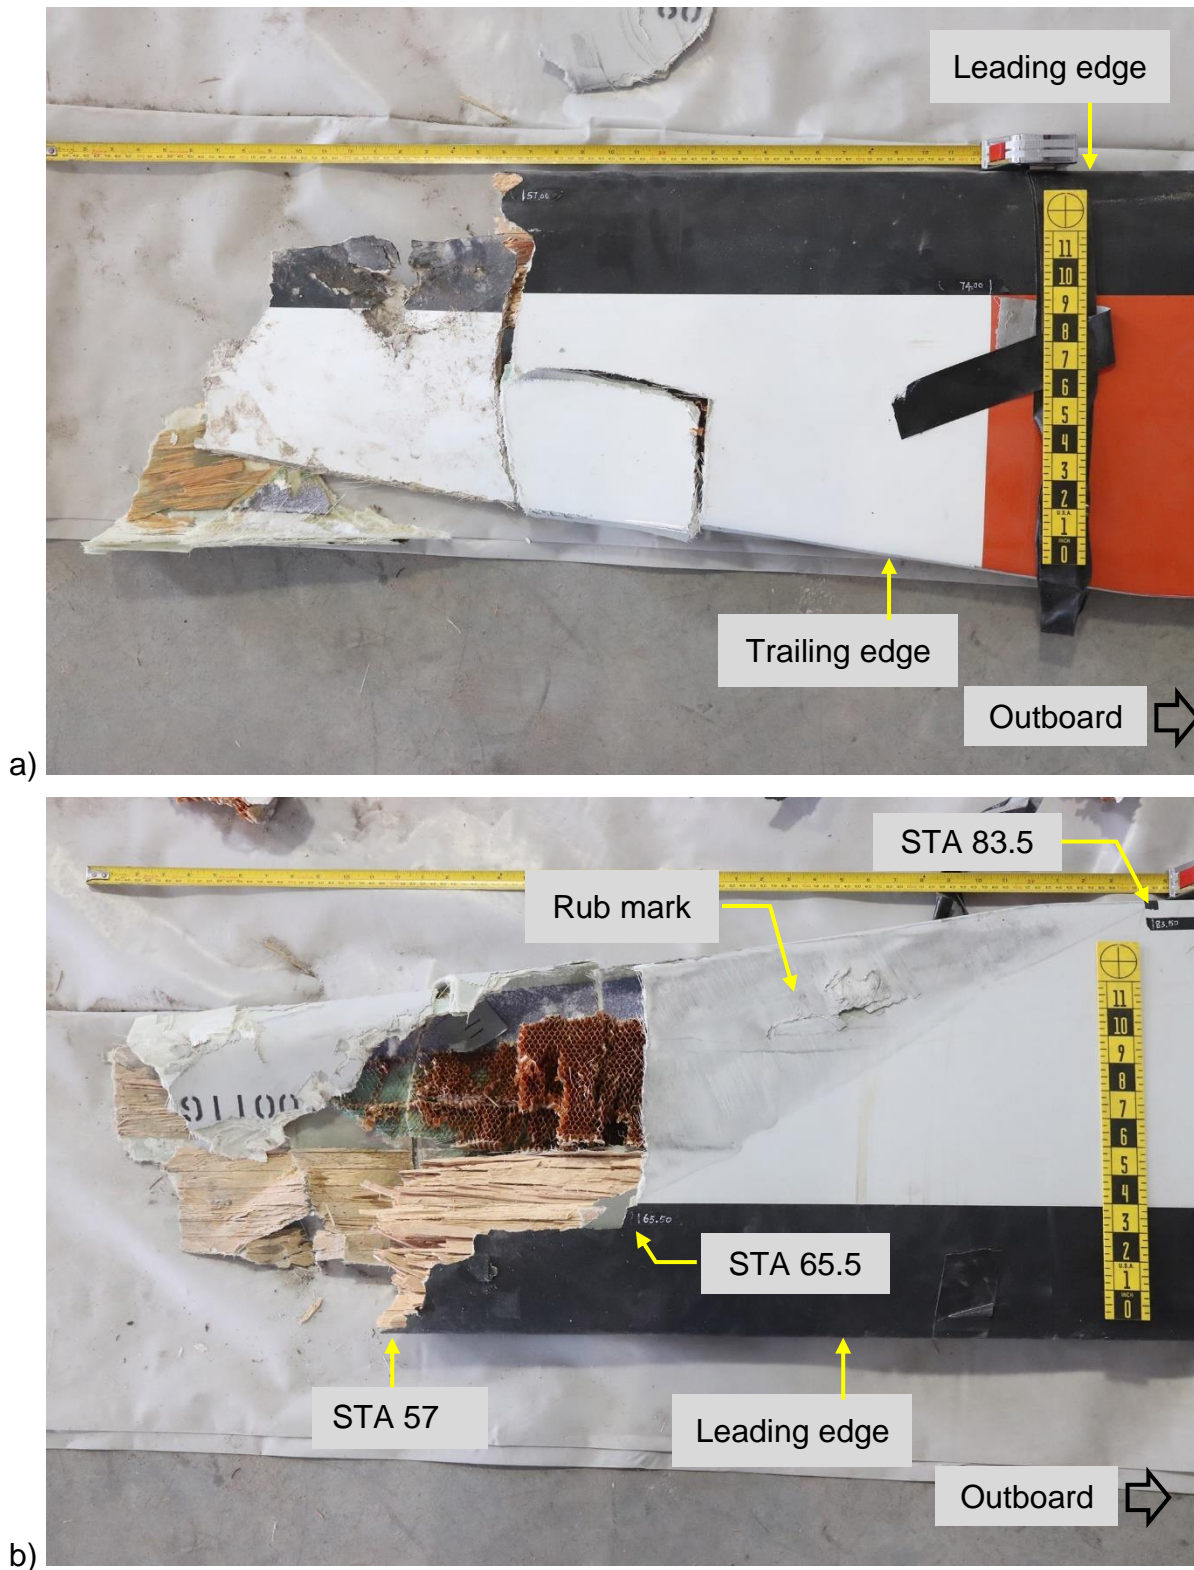
There was a rub mark on the lower surface of the LHR blade, as indicated in figure 6b. The rub mark was roughly triangular in shape. The forward edge of the rub mark ran at an angle across the lower blade surface from the middle (chordwise) of the spar at STA 65.5 to the trailing edge at STA 83.5. The aft edge of the rub mark ran along the blade's trailing edge between STA 65.5 and STA 83.5. Inboard of STA 65.5 a strip of the lower skin was missing that was approximately in line with and at the same width and angle as the rub mark. Examination of the RHW (470A) rotor blade revealed a scuff and blunt impact mark along the leading edge of the blade between approximately STA 32 and STA 50, as shown in figure 8.

Figure 6. Images of the outboard side of the LHR (473B) blade root fracture: a) upper surface and b) lower surface.

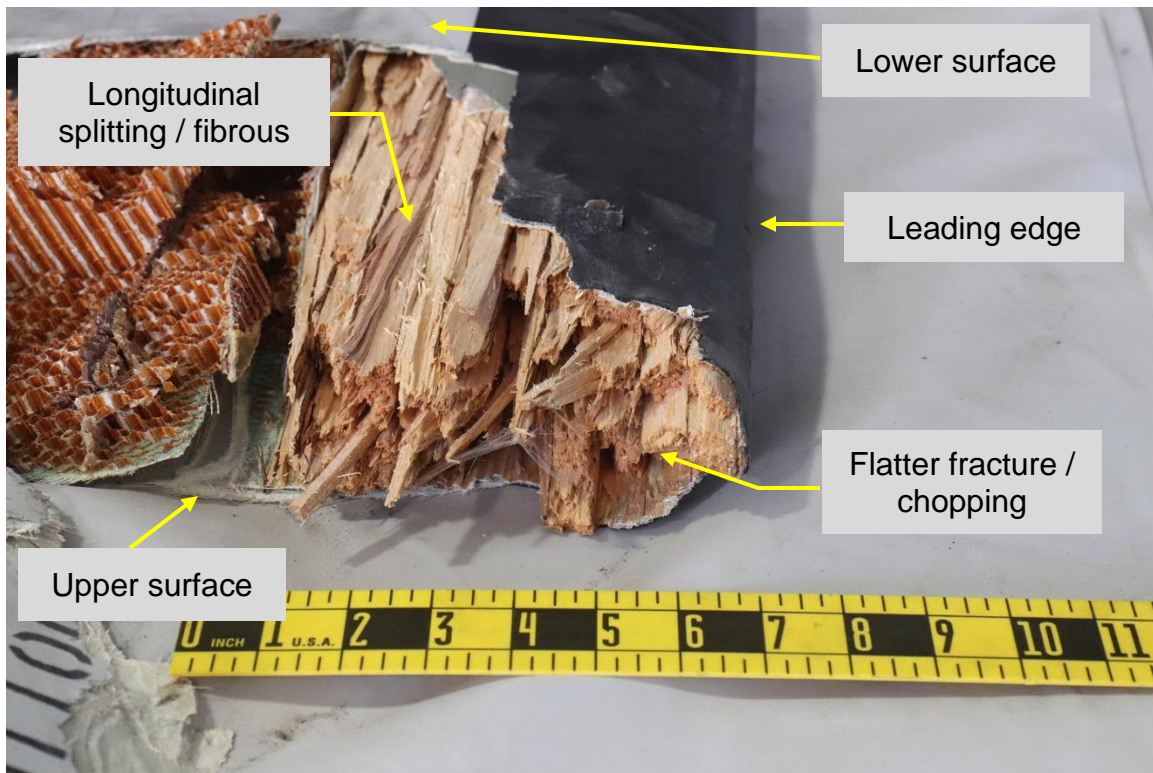
Figure 7. Image of the outboard side of the LHR blade spar fracture.

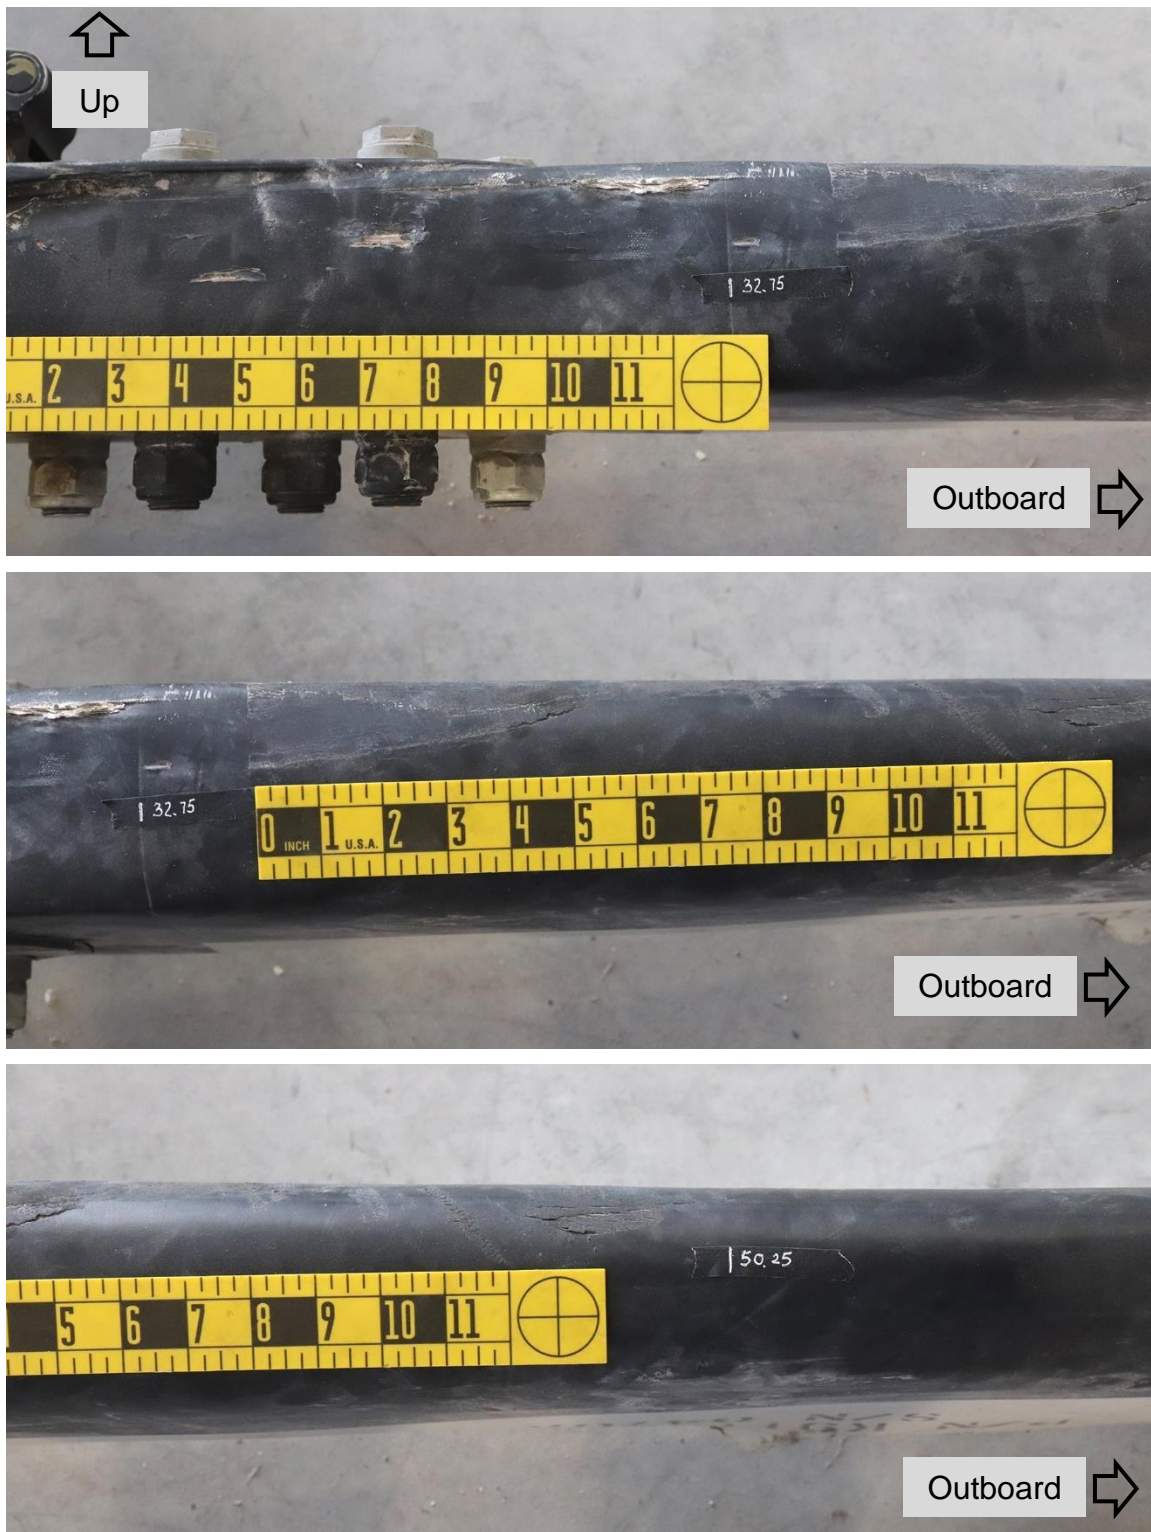
Figure 8. Scuff and impact marks along the leading edge of the RHW (470A) main rotor blade.

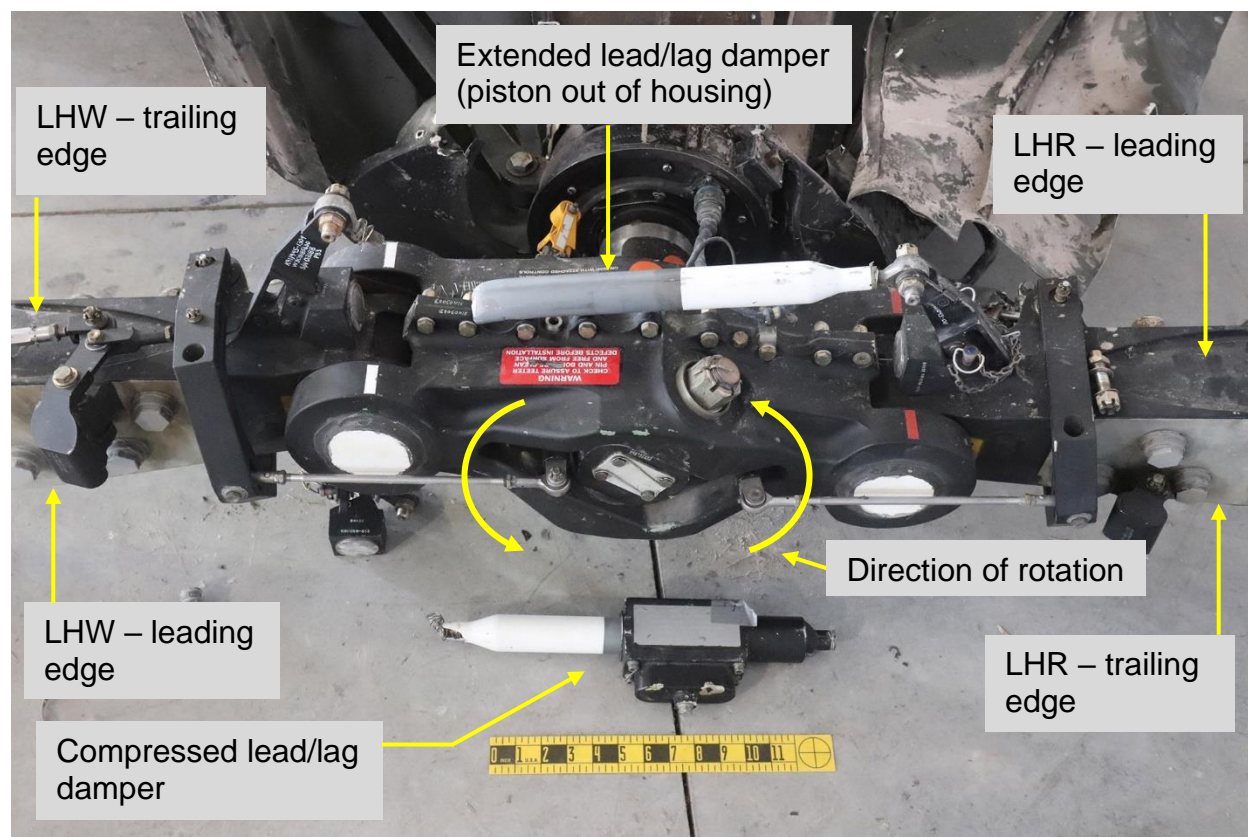
to a blade by a spherical bearing rod end. As the length of one damper shortens, the other damper lengthens. As shown in figure 9, the piston for the damper between the leading side of the LHR and the trailing side of the LHW blade had extended and pulled free of the housing. In contrast, the piston for the damper between the leading side of the LHW blade and the trailing side of the LHR blade was fully compressed and was separated from the rotor hub.

Figure 9. Image of the left rotor hub and lead / lag dampers. The damper connecting the leading edge of the LHR blade to the trailing edge of the LHW blade was extended and the piston had separated from the housing. The damper connecting the leading edge of the LHW blade to the trailing edge of the LHR blade was compressed.

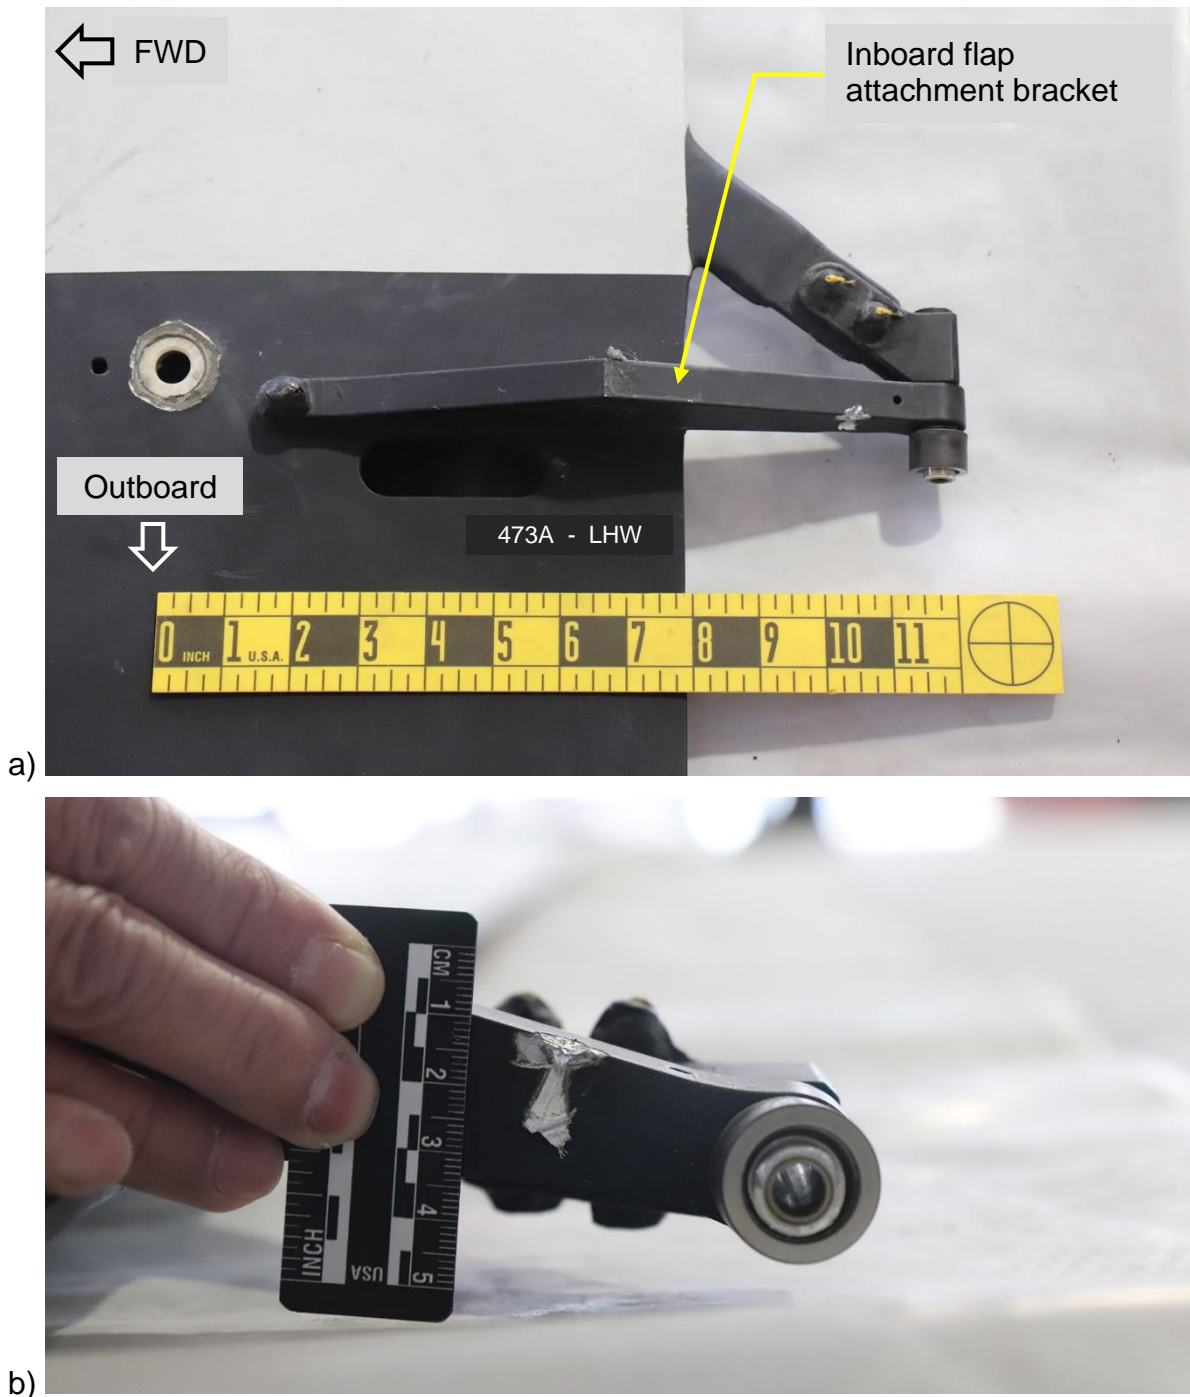
Contact marks were observed on the inboard servo flap attachment brackets in line with the bolt head used to connect the servo flap control rod to the pitch change horn on the flap. Views of the inboard bracket for the LHW rotor blade are shown in figures 10a and b. The control rod was removed prior to the wreckage exam. The bracket for the LHR blade is shown in figures 11a and b and the RHW and RHR brackets are shown in figures 12a and 12b, respectively. Comparing figures 11, 12a, and 12b, the bolt head was aligned with the contact mark on the bracket when the rod was retracted (corresponding to a flap configuration of leading edge up).

All inboard brackets showed indications of contact along their lower outboard edge. The contact marks also extended from the lower edge along the side of the bracket, but to varying lengths. The mark on the LHW bracket, shown in figure 10b, extended approximately 0.60 inch up from the edge and the mark on the LHR bracket, shown in figure 11b, extended approximately 0.30 inch up from the edge. The marks on the RHR and RHL brackets extended approximately 0.16 inch and 0.07 inch from the edge, respectively.

Figure 10. Inboard flap attachment bracket for the LHW servo flap: a) View of lower blade surface and b) view of contact marks on inboard bracket.

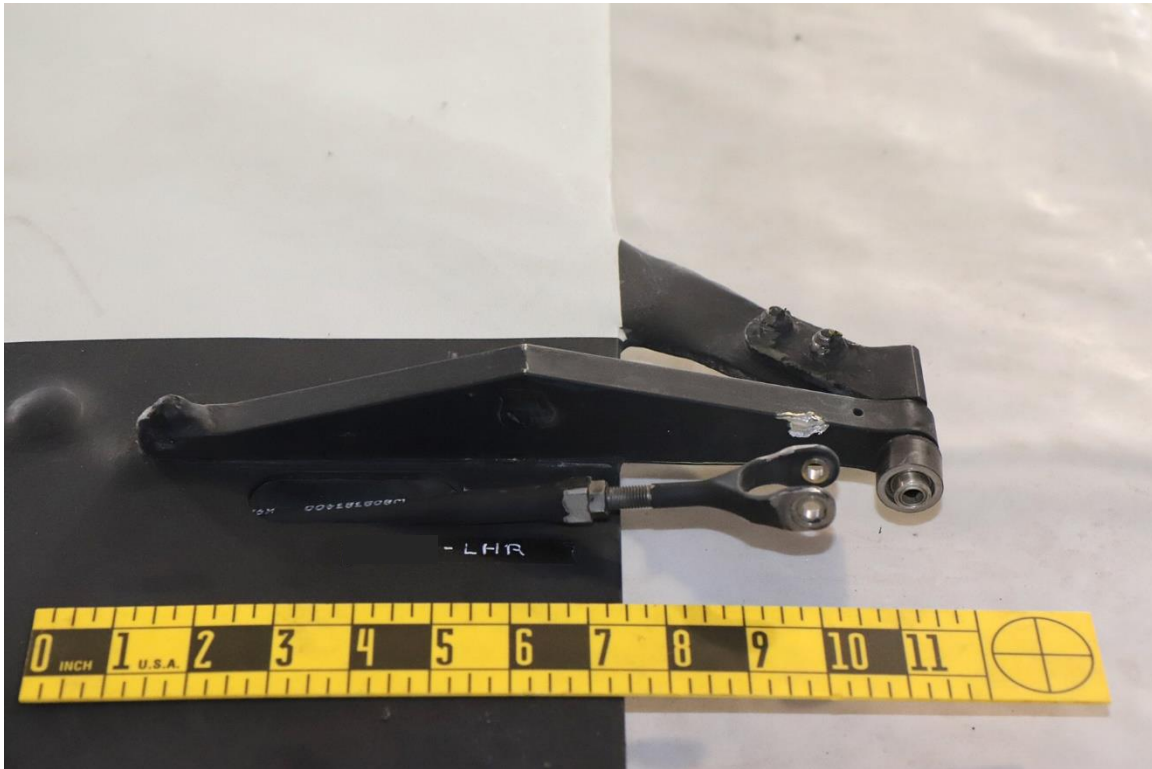
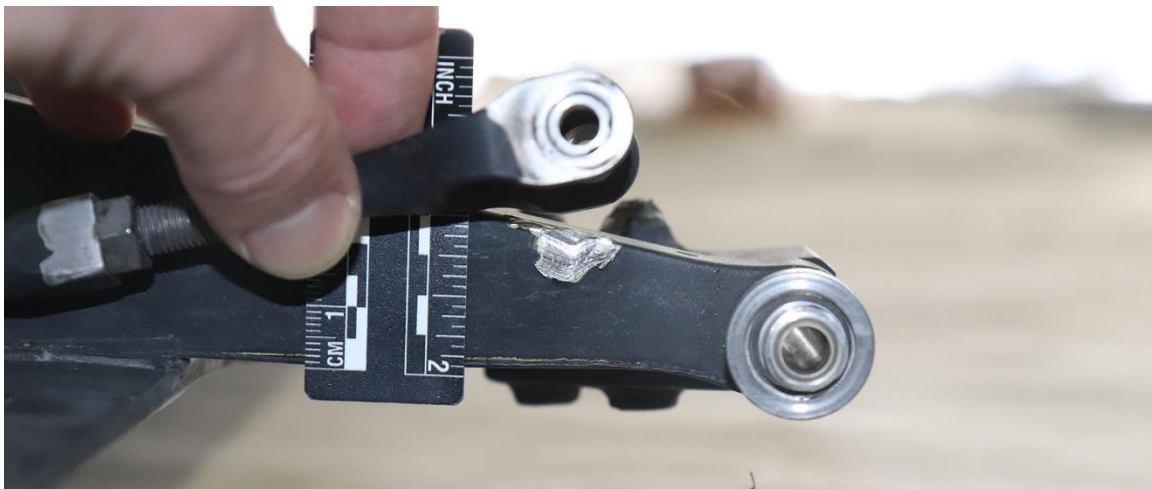
Figure 11. Inboard flap attachment bracket for the LHR servo flap: a) View of lower blade surface and b) view of contact marks on inboard bracket.

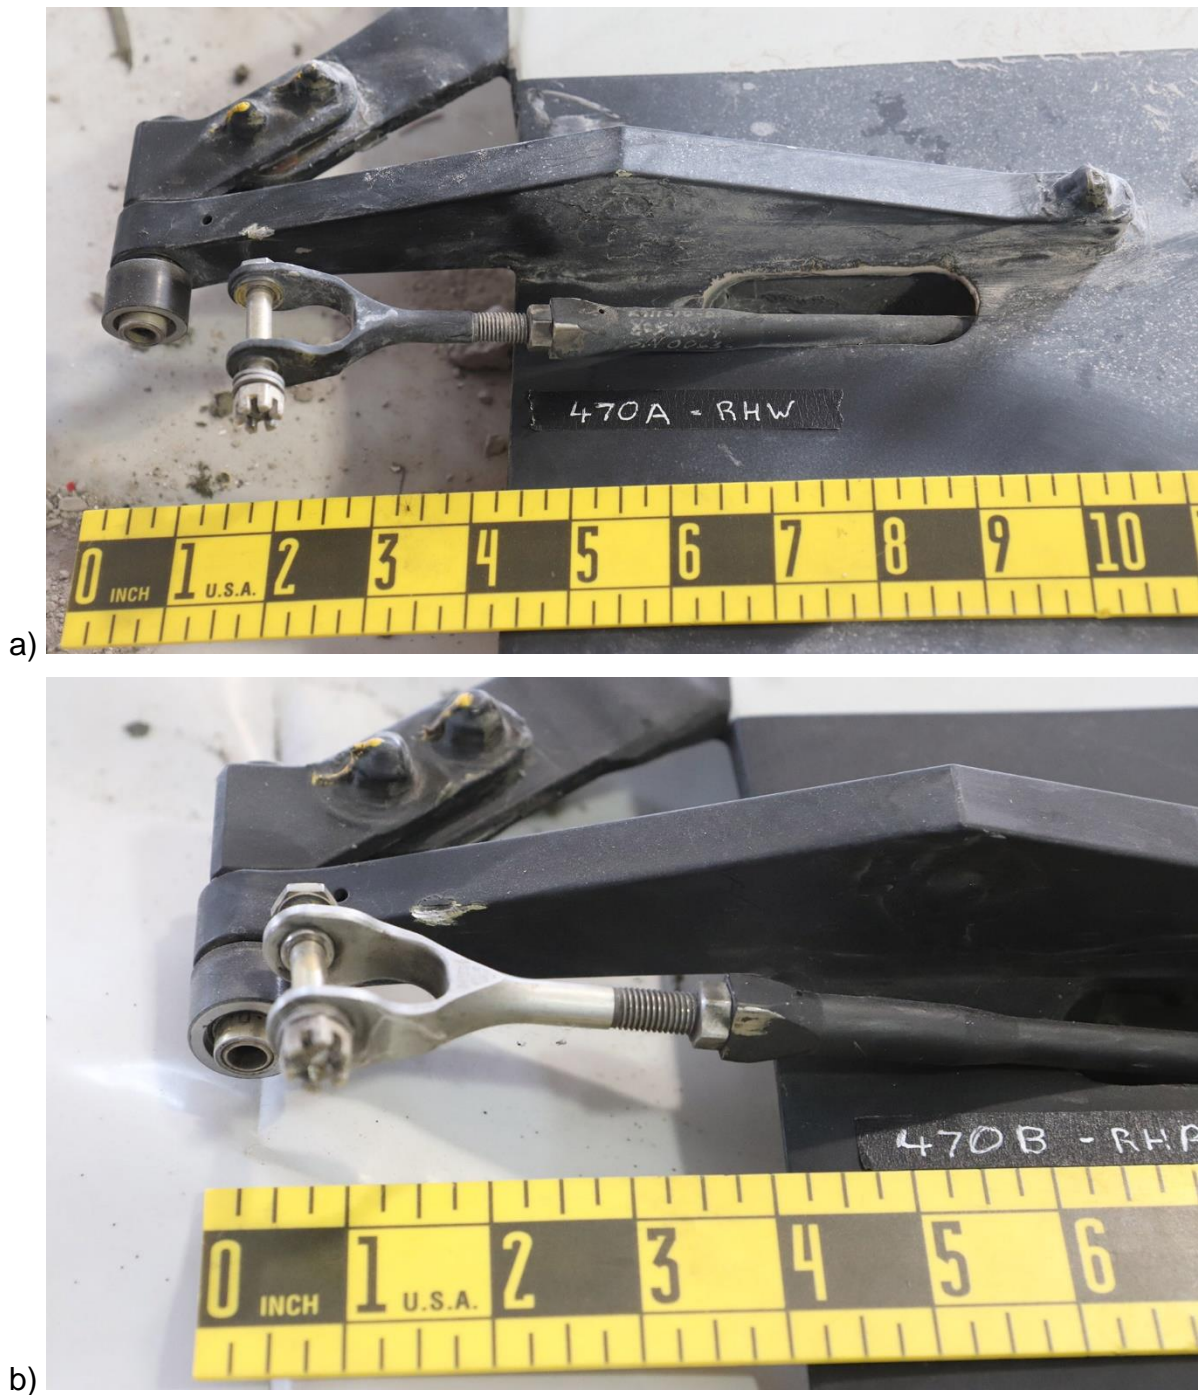
Figure 12. Views of contact marks on the right-hand rotor inboard flap attachment brackets: a) RHW and b) RHR.

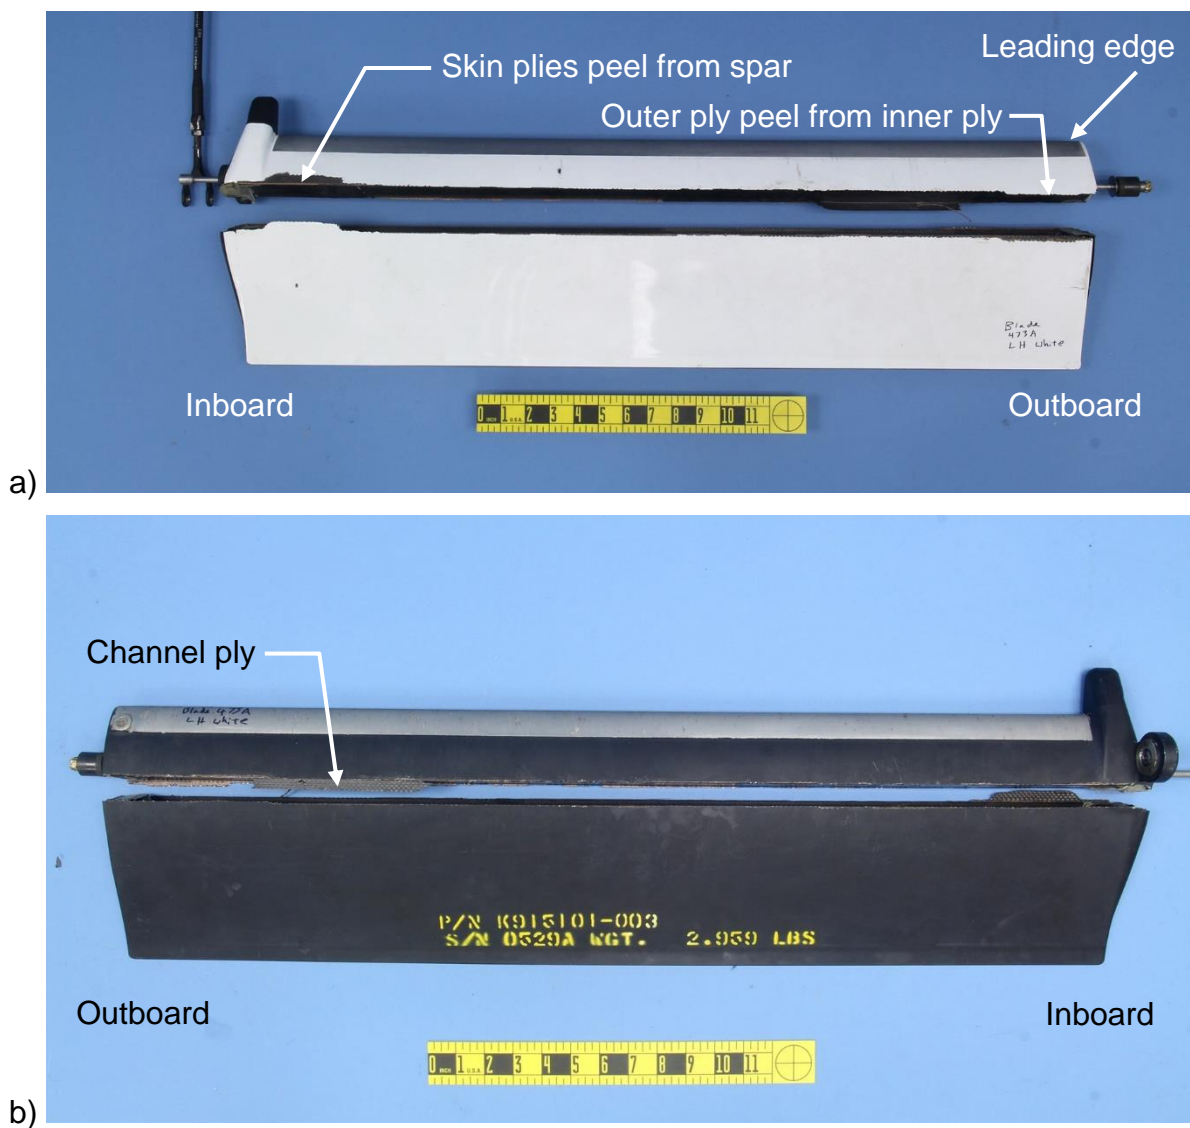
Along the upper surface, the afterbody skin plies initially fractured along the aft edge of the inboard fitting. Immediately outboard of the fitting, the plies began to peel from the spar, as seen in figure 13a and figure 20. The peel region extended approximately 3 inch in the spanwise direction and up to approximately 0.45 inch in the chordwise direction. Similar to the channel ply separation, fractographic examination indicated that the separation occurred primarily along the interface between the inner skin ply's woven fibers and the adjacent interlayer resin with occasional deviations into the resin as it encountered weft-aligned fiber tows. The resin fractures were consistent with the separation proceeding in the outboard direction. Outboard of this region, the skin plies had fractured at or near the spar-to-afterbody transition. Along the outermost 3.5 inch, the outer skin ply exhibited a small peel separation from the inner skin ply on the afterbody-side of the separation, as indicated in figure 13a. The peel extended up to approximately 0.25 inch the chordwise direction.

Figure 13: Separated servo flap assembly from the left rotor / white main rotor blade (LHW - Blade 473A), as received: a) view of the flap upper side and b) view of flap lower side.
